# **Effect of Roof Material on Water Quality for Rainwater Harvesting Systems – Additional Physical, Chemical, and Microbiological Data**

## **Report**

## **Texas Water Development Board**

**January 2011**

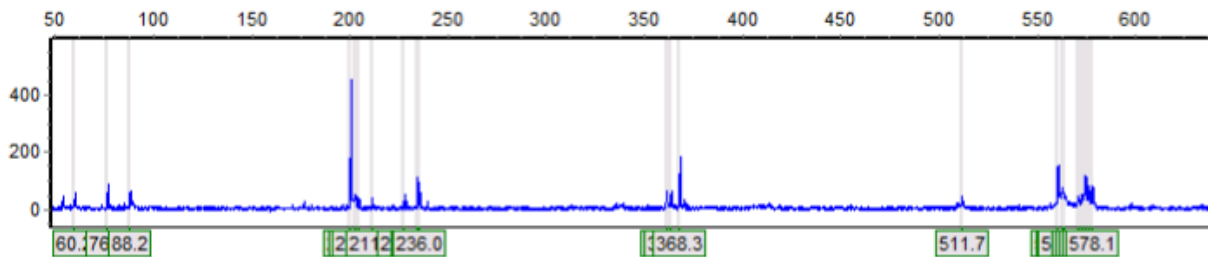
Figure 9-1. DNA fragments from T-RFLP for green roof (tank 1). Note: x-axis shows base pairs and y-axis shows peak heights (relative fluorescence units).
